**Ingress Protection test on a
Pressure vent on behalf of AFP Air Tech**

Report No: N70090752A
Commercially in Confidence

TEST REPORT

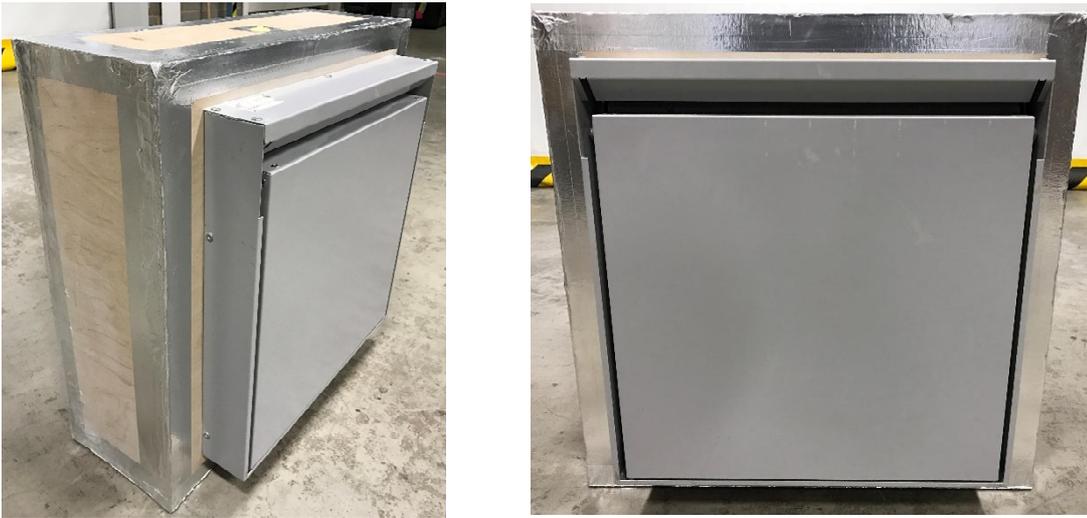
Figure 1 – Typical views of pressure vent fitted to customer supplied test enclosure

For the purposes of test, the customer supplied the pressure vent fitted to a bespoke wooden enclosure allowing inspection for water ingress via the rear panel and to provide an enclosure suitable to allow a 20 mbar vacuum point required for the IP6X test

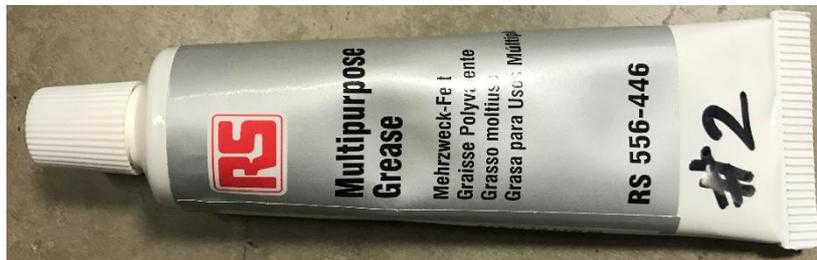
Figure 2 – Customer provided 'multi purpose' grease for the IP6X test only

The customer supplied a tube of multi purpose grease for the purpose of this test (see figure 2). At the request of the customer, a thin layer of grease was applied around the gasket between the pressure vent and main body, see Figure 3.

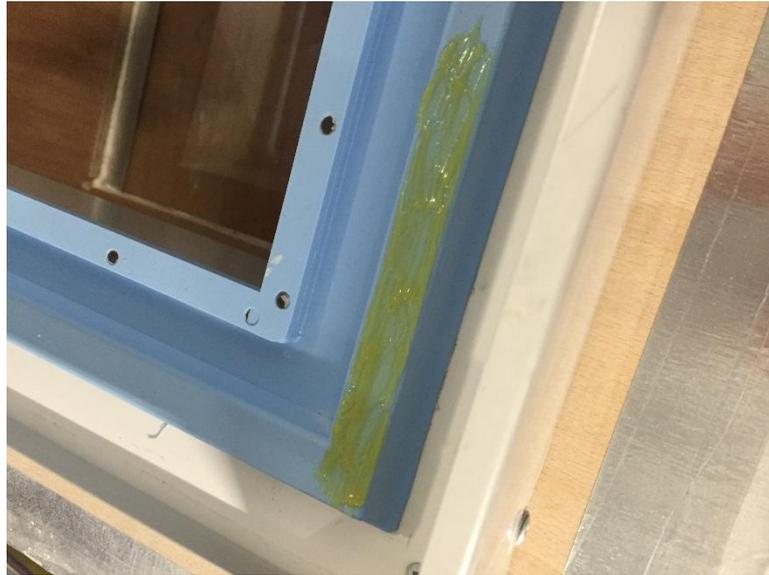
Figure 3 – Multi purpose grease provided for the IP6X test (*NOTE: Image only shows part of the gasket, the full gasket was lubricated prior to testing*).
