A Fire Resistance Test
Generally In
Accordance with BS EN
1634-1: 2014 On A Pressure
Relief Damper in an Aerated
Blockwork Wall

359639

AFP Air Tech Limited

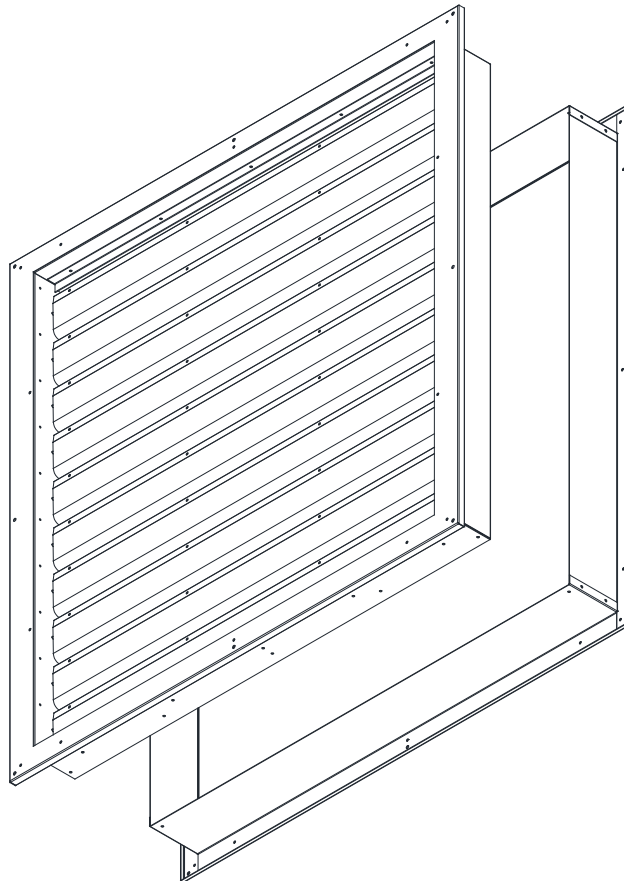
Figure 2 – Isometric View of Damper Sections

WALL CUT OUT SIZE
1060 Wide x 1050 High

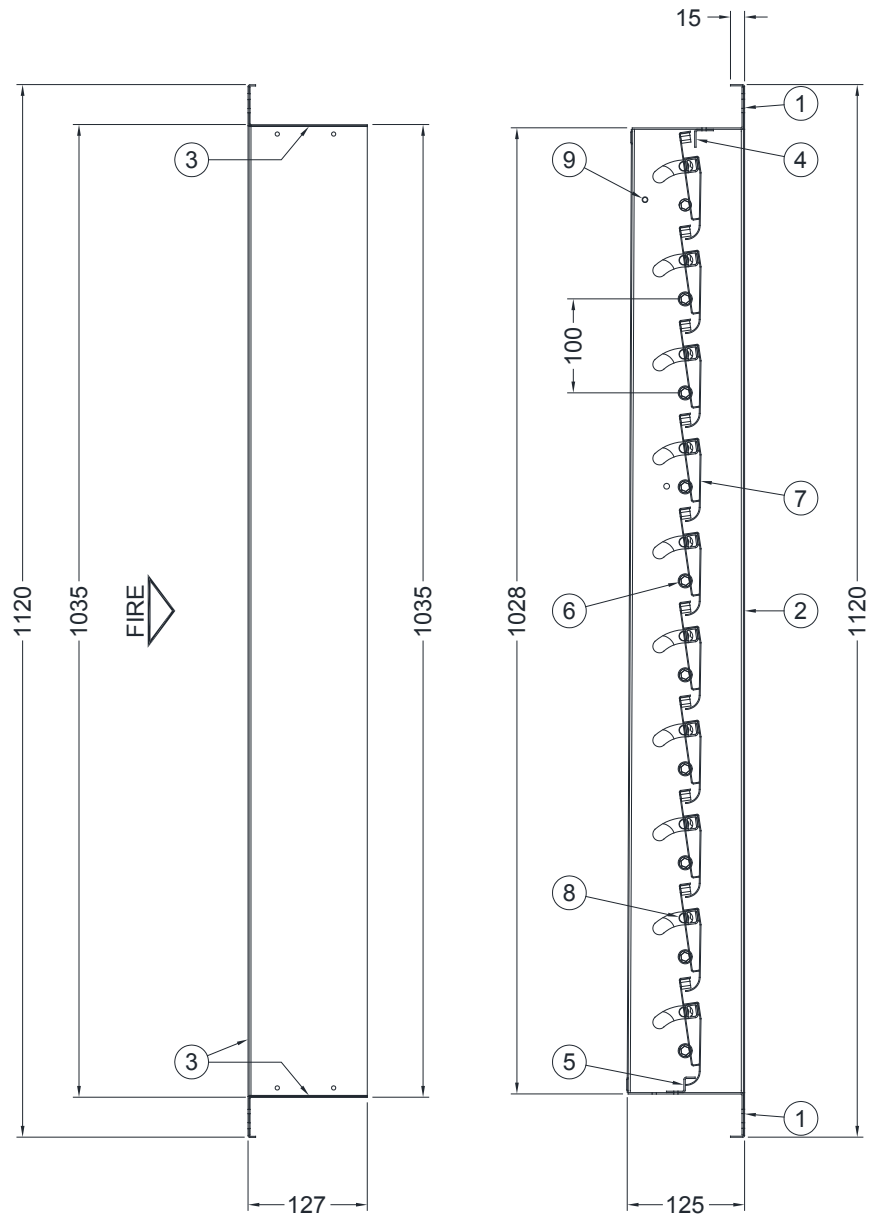
Figure 3 – Details of Damper

All undimensioned holes 4.5mm diameter
All dimensions $\pm 0.2\text{mm}$

6. Blade Stop Stud	
Material	: Steel
Overall size	: 12.8 mm diameter with 6.2 mm projection
Fixing method	: Through screwed into damper frame side assemblies, item 2, at 100 mm centres, please see Figure 3 for positions

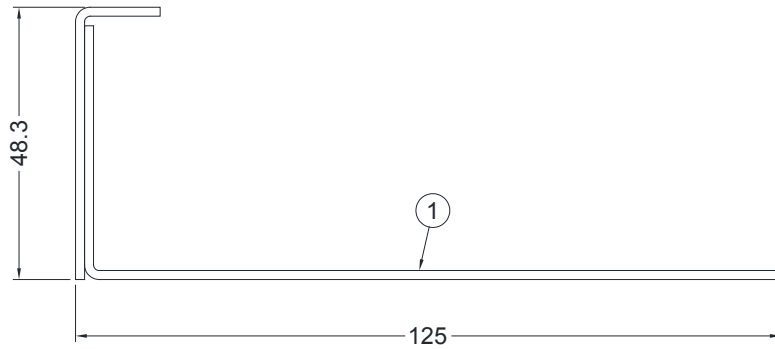
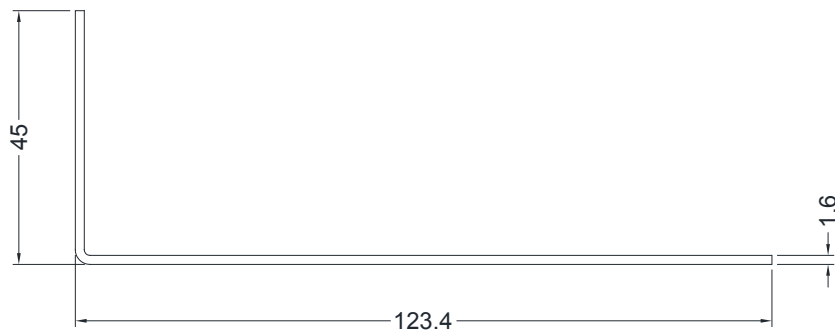
Figure 4 – Details of Damper Frame

TYPICAL SECTION THROUGH
CASING TOP & BOTTOM ASSEMBLY

<u>Item</u>	<u>Description</u>
1. Damper Frame Head & Base Assembly	
Material	: Mild steel
Thickness	: 1.6 mm
Overall size	: 126.6 mm x 48.3 mm, please see Figure 4 for more dimensions
Jambs to head jointing method	: 4 mm steel rivets
Fixing methods

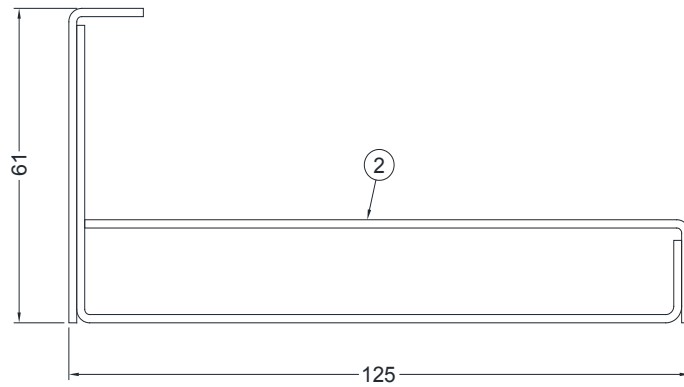
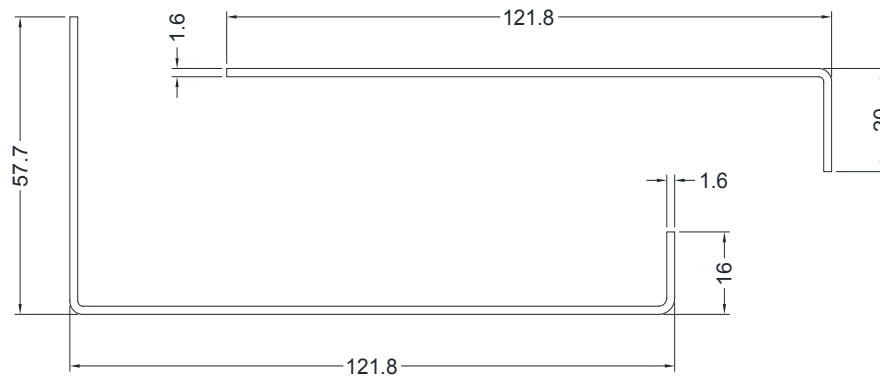
Figure 5 – Details of Damper Frame

TYPICAL SECTION THROUGH
CASING SIDE ASSEMBLY

i. components together	: Pop riveted
ii. to supporting construction	: 63 mm long x 4.2 mm diameter countersunk head screws, 2 off per length
2. Damper Frame Side Assembly	
Material	: Mild steel
Thickness	: 1.6 mm
Overall size	: 126.6 mm x 48.3 mm, please see Figure 5 for more dimensions
Jambs to head jointing method	: Please see item 1
Fixing methods

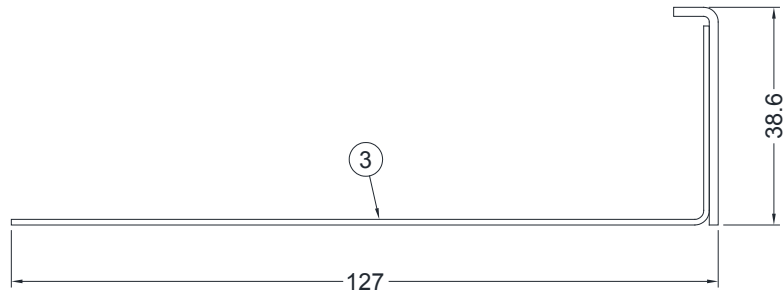
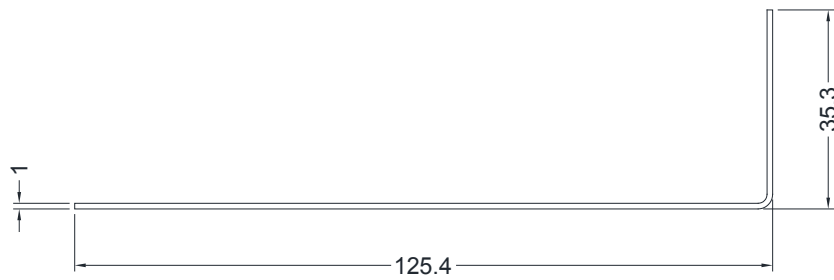
Figure 6 – Details of Liner Frame

TYPICAL SECTION THROUGH
LINER FRAME ASSEMBLY

i. inner angle	: 1 mm
ii. outer angle	: 1.6 mm
Overall size	: 127 mm x 38.6 mm, please see Figure 6 for more dimensions
Jambs to head jointing method	: 4 mm steel rivets
Fixing methods

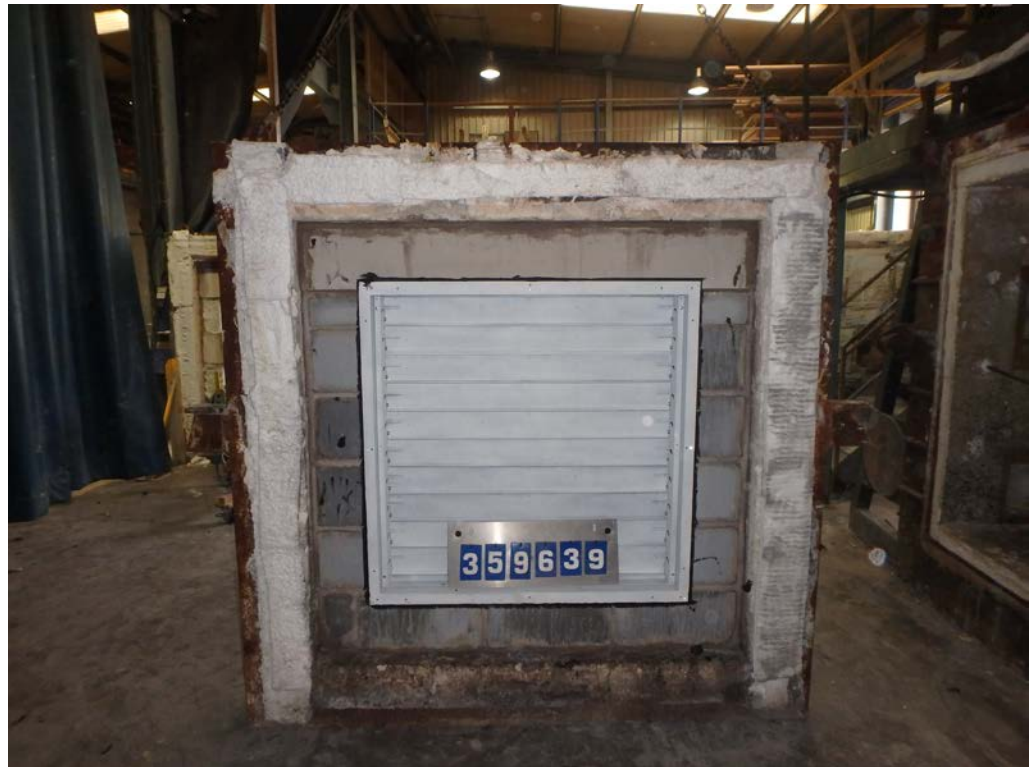
The exposed face of the specimen prior to testing

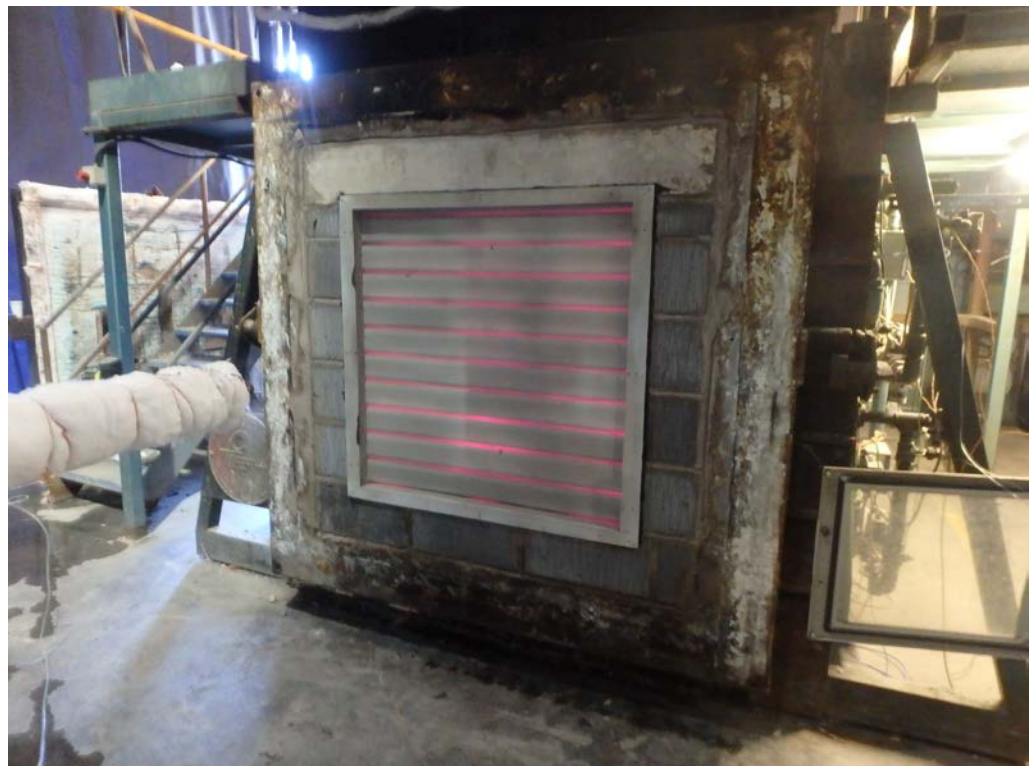
The unexposed face of the specimen after 30 minutes of testing

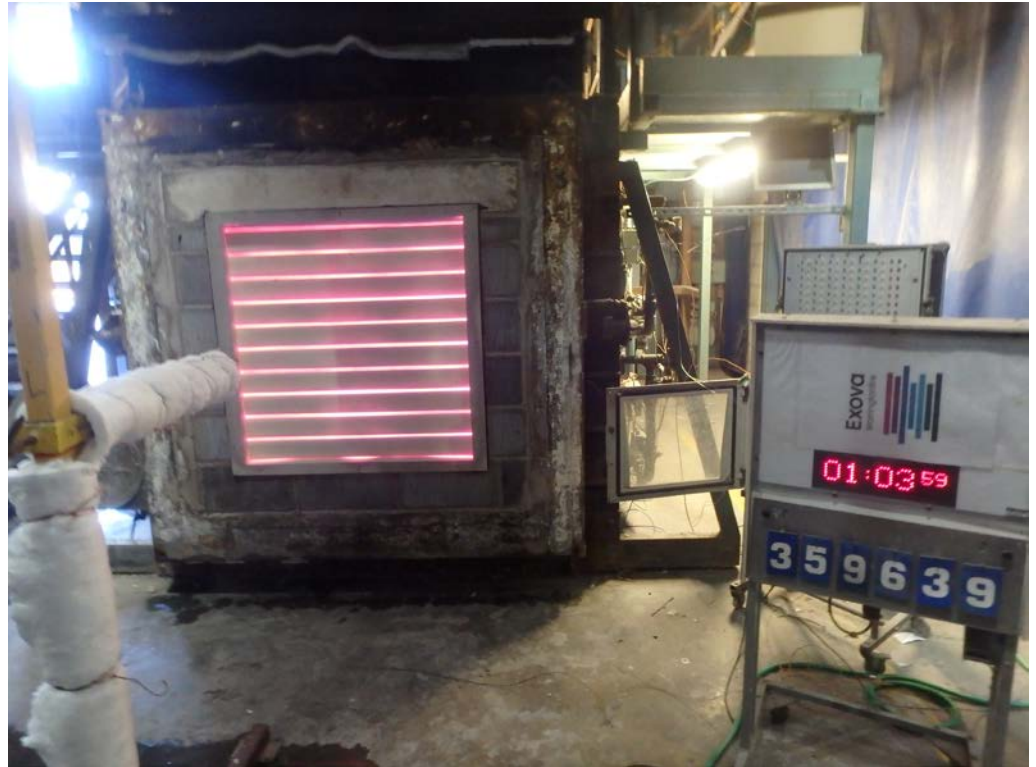
The unexposed face of the specimen after 63 minutes of testing

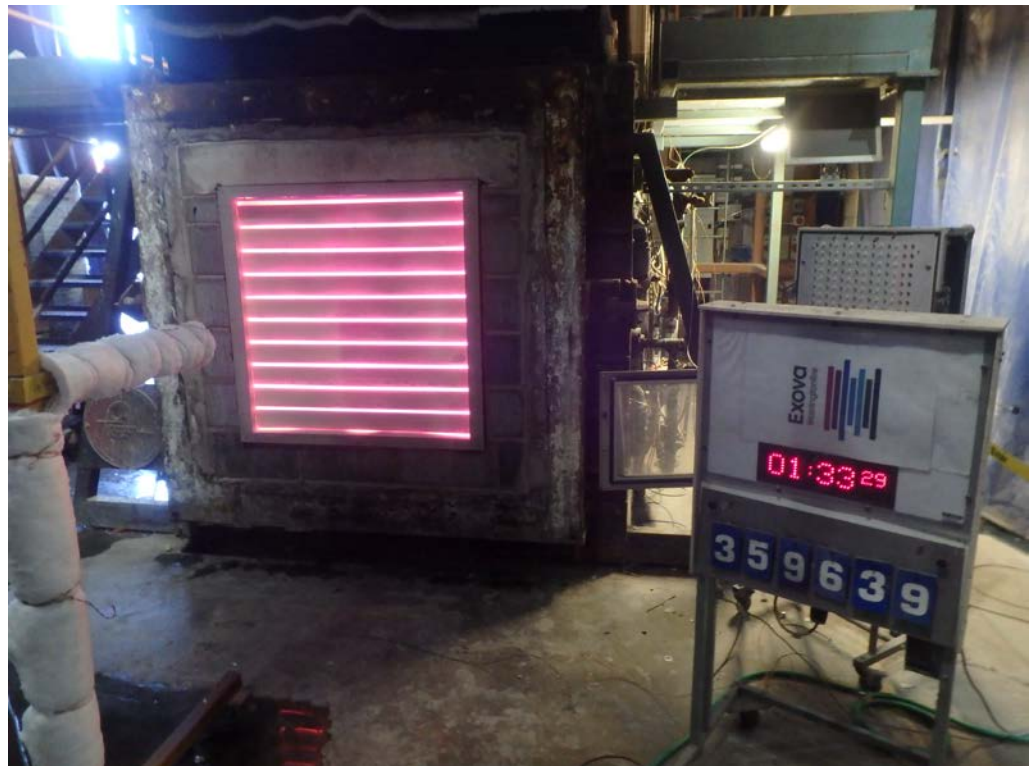
The unexposed face of the specimen after 93 minutes of testing

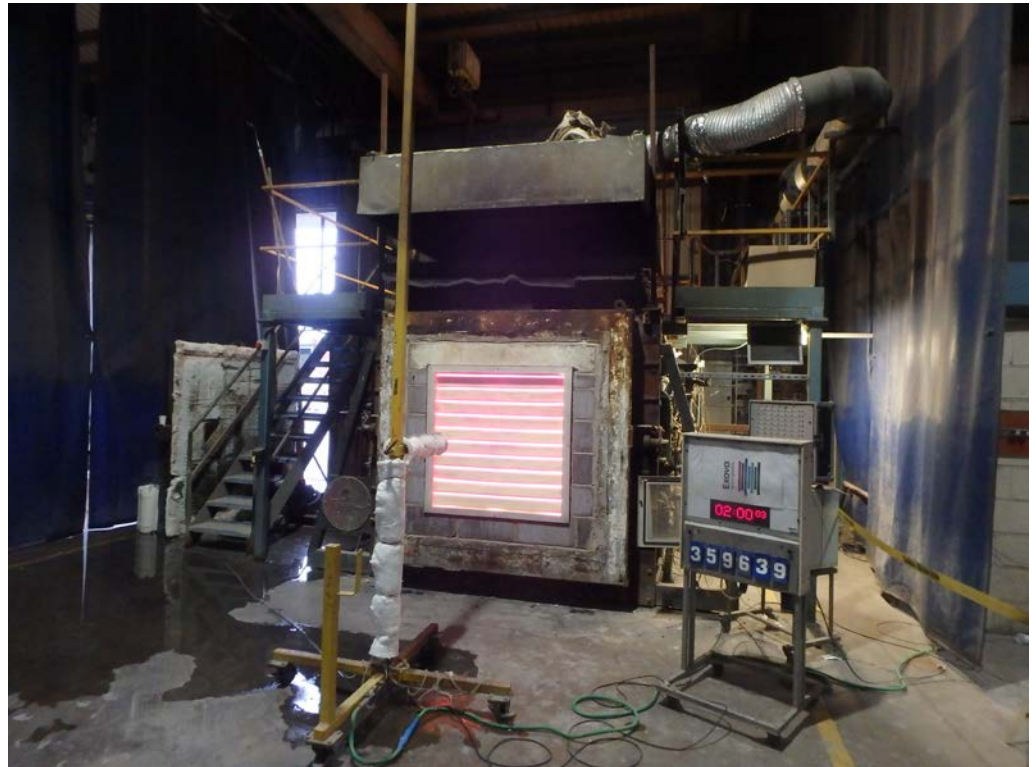
The unexposed face of the specimen after 120 minutes of testing

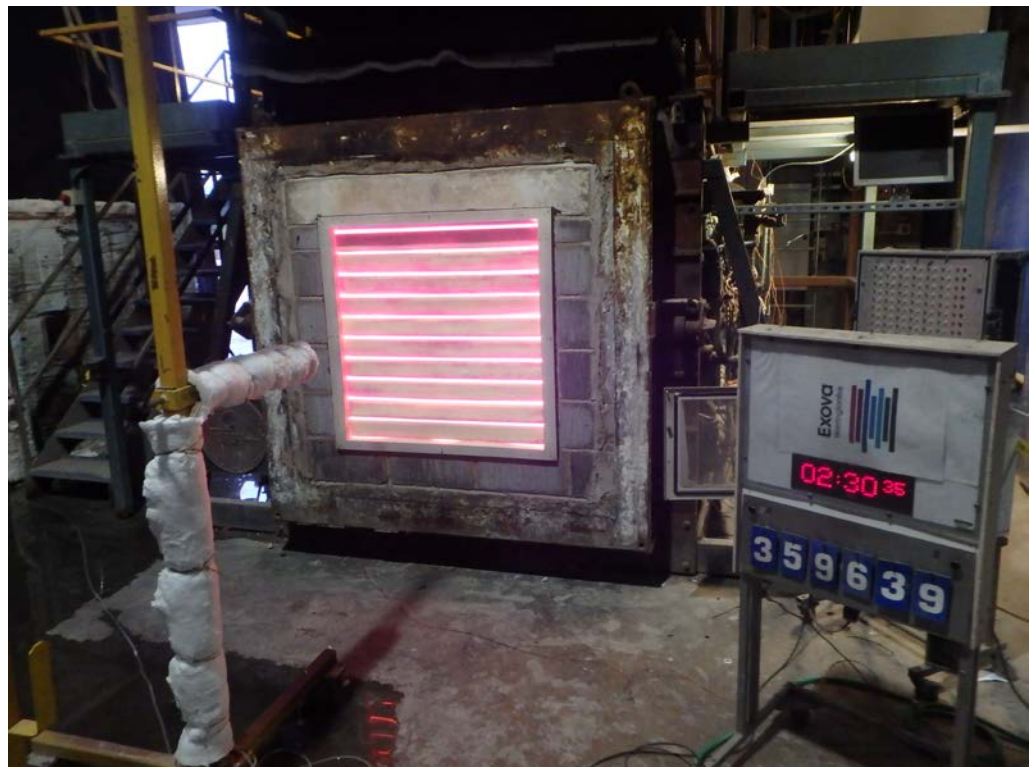
The unexposed face of the specimen after 150 minutes testing

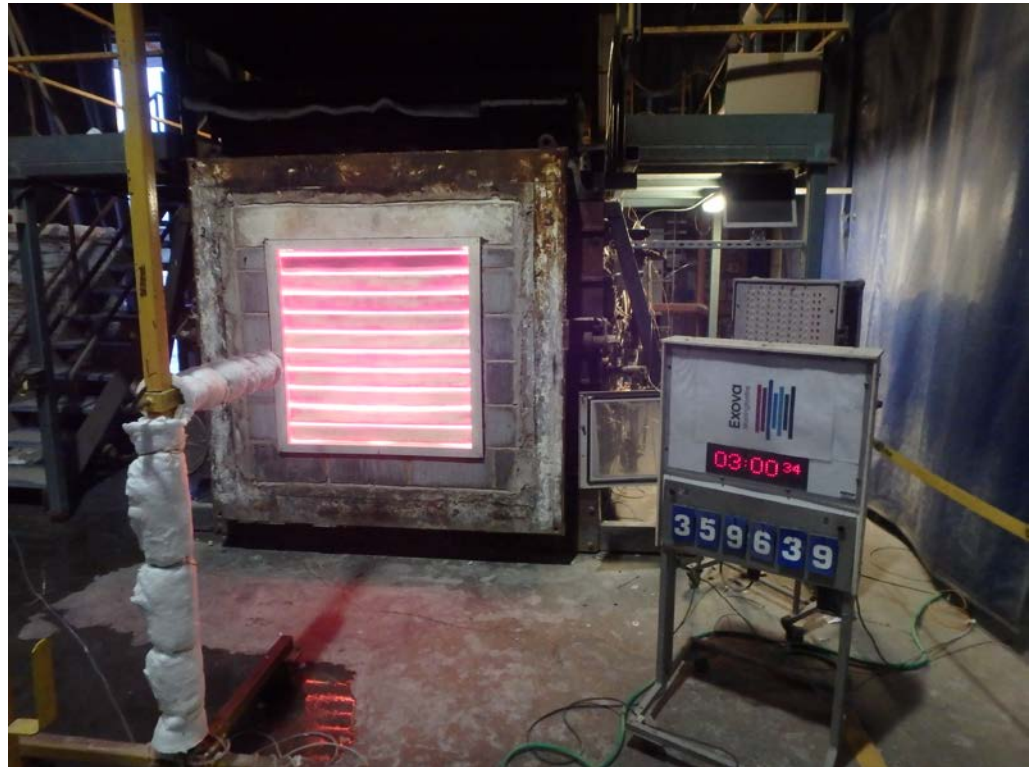
The unexposed face of the specimen after 180 minutes of testing

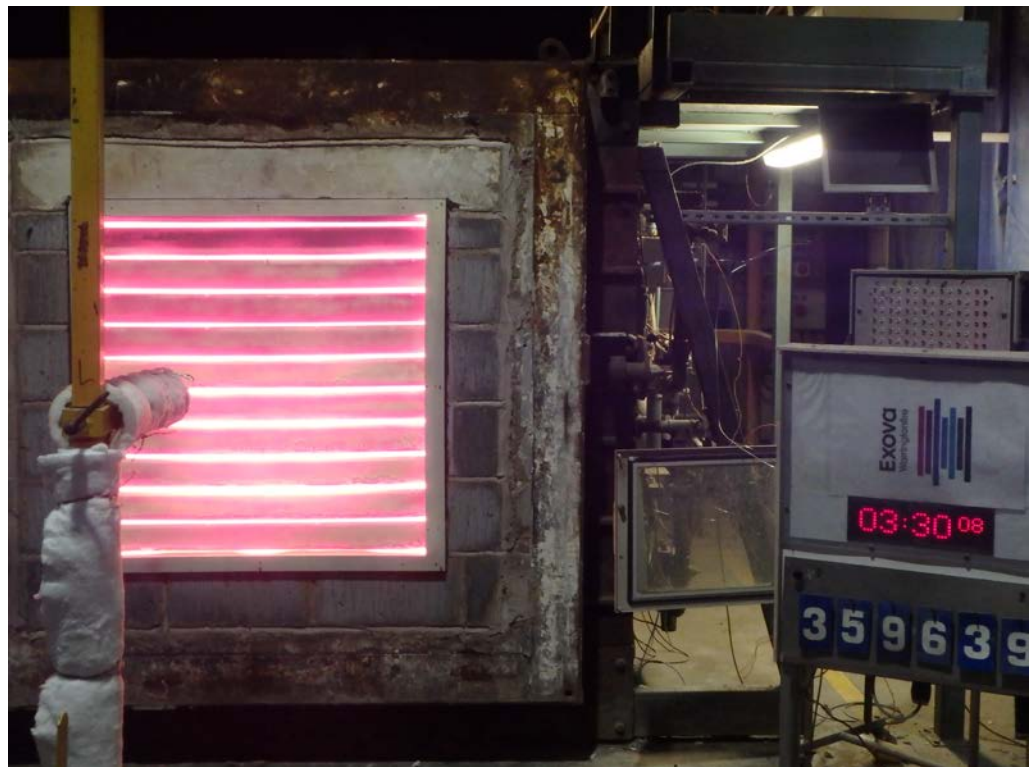
The unexposed face of the specimen after 210 minutes of testing

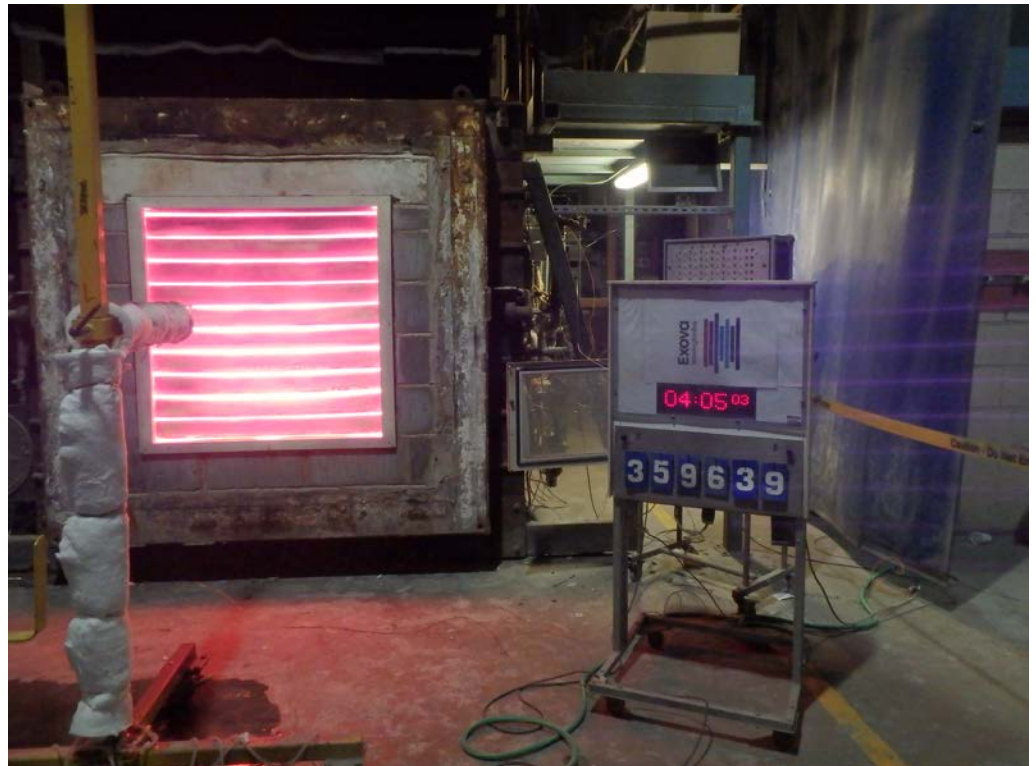
The unexposed face of the specimen after 245 minutes of testing

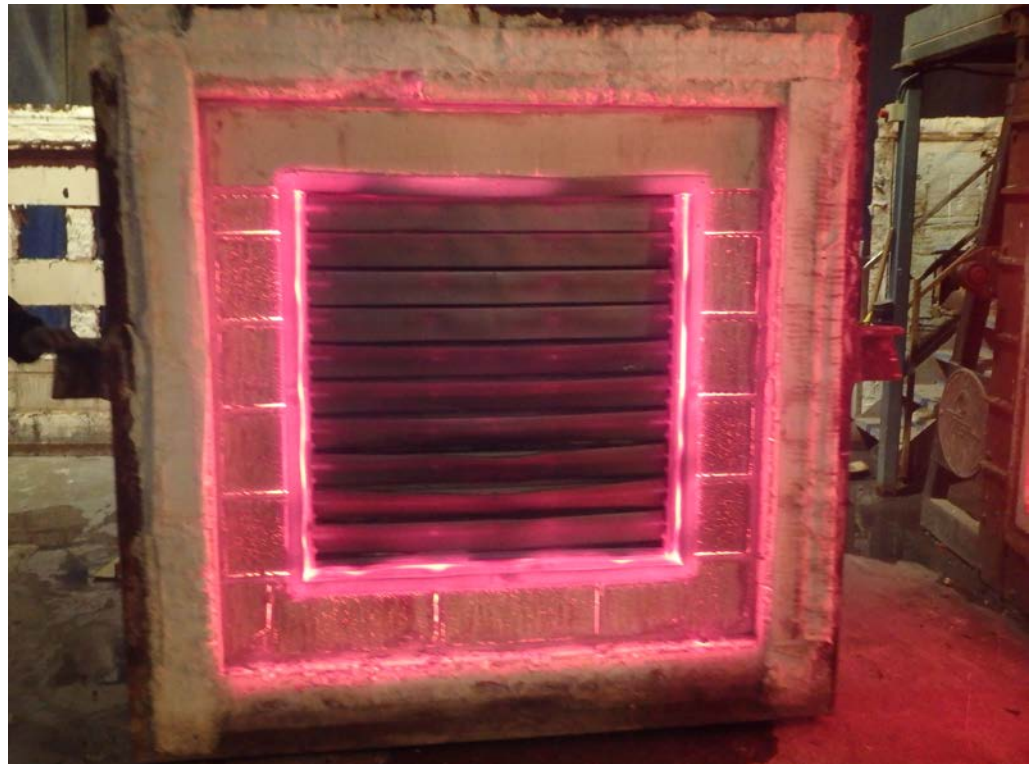
The exposed face of the specimen shortly after the test

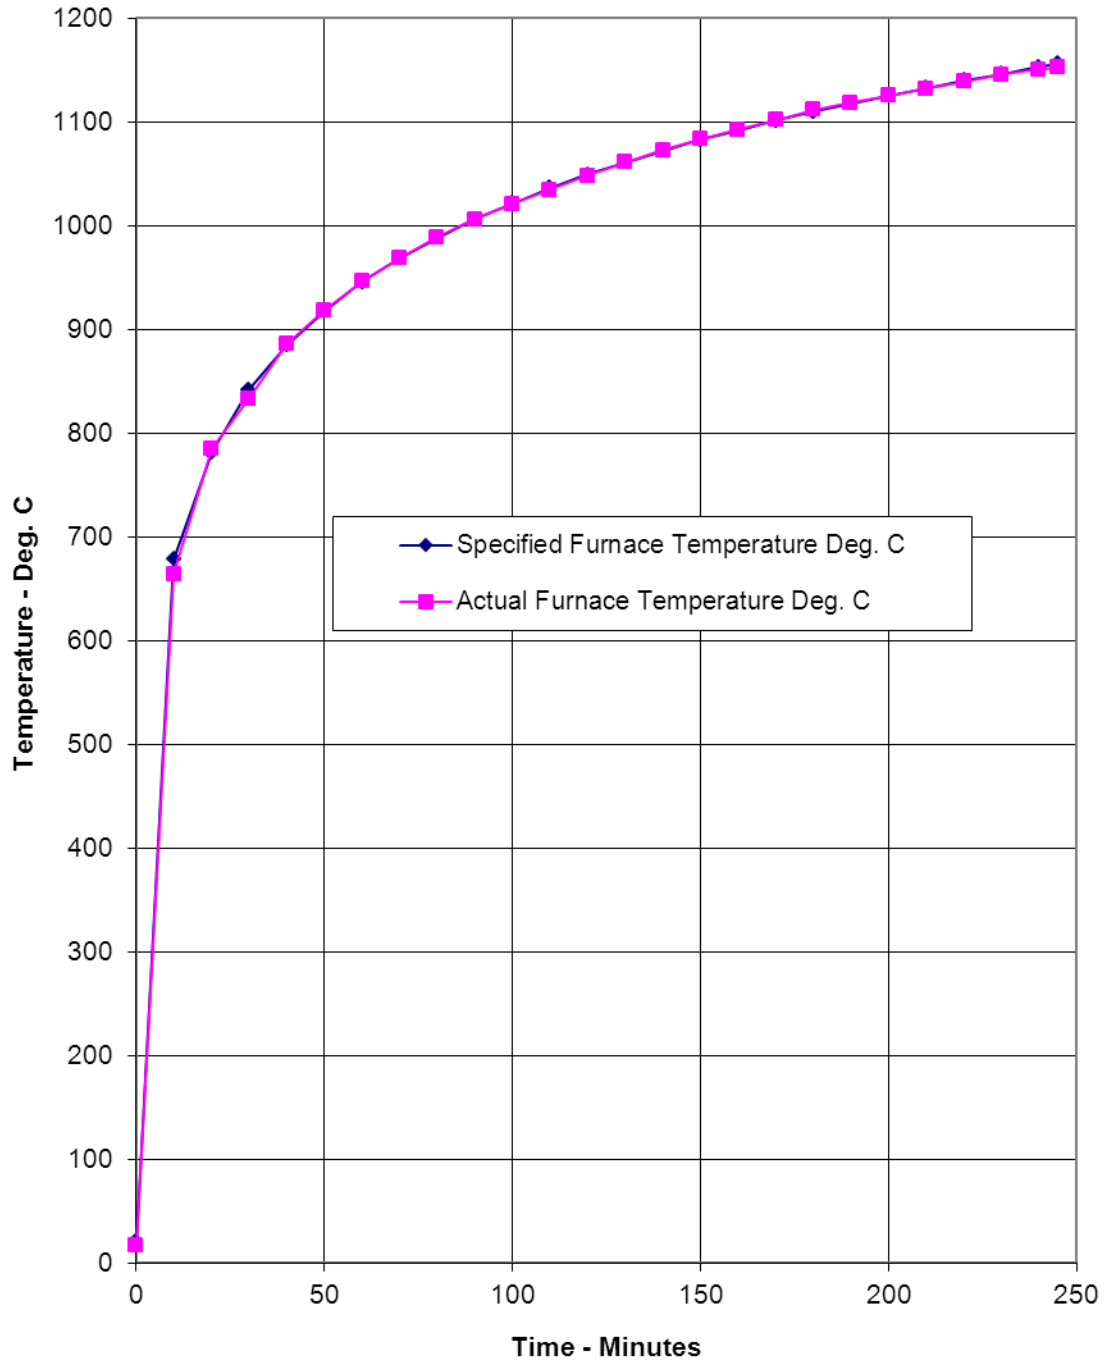
Graph Showing Mean Furnace Temperature, Together with the Temperature/Time Relationship Specified in the Standard

Time Mins	Specified Furnace Temperature Deg. C	Actual Furnace Temperature Deg. C
0	20	17
10	678	664
20	781	785
30	842	833
40	885	886
50	918	918
60	945	946
70	968	968
80	988	989
90	1006	1006
100	1022	1021
110	1036	1035
120	1049	1048
130	1061	1061
140	1072	1073
150	1082	1083
160	1092	1093
170	1101	1102
180	1110	1111
190	1118	1118
200	1126	1125
210	1133	1132
220	1140	1139
230	1146	1146
240	1153	1151
245	1156	1153
