Gas System Pressure Venting Tests 8th April 2008

Appendix A – Gas System Pressure Venting Tests, 8th April 2008

Appendix B – AFP report (appendices supplied to BRE but not included here)

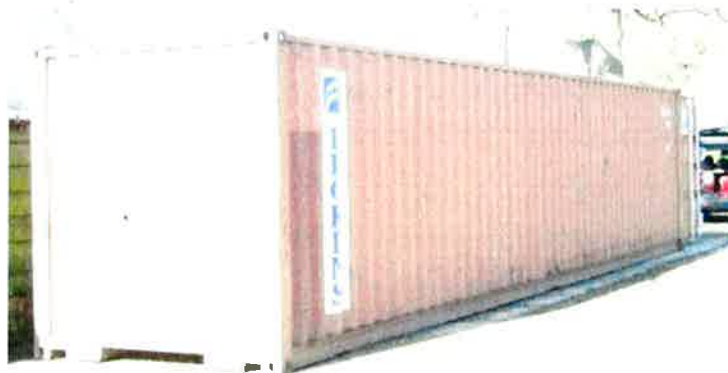
Figure 1 – Steel container facility for gas systems tests

The test facility comprised an ISO steel container with a wooden partition across the width providing a test room with a volume of 43 m³ (measurements not formally verified by BRE), see Figure 2. The test room was instrumented to allow for continuous measurement and recording of pressure, temperature, air flow and pressure vent blade operation (degree of opening). Room oxygen concentration was also measured but not recorded. Datasheets and information related to the instruments used was supplied to BRE. Tests and pressure vent blade operation were video recorded as appropriate and supplied to BRE in the form of a compilation video.

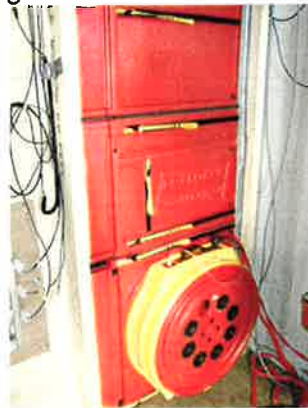
A number of room integrity tests were conducted by Mr Colin Uzzell of G & D. This provided AFP with independent room integrity testing data and an accompanying report, see Appendix C. G & D report that the testing was carried out in accordance with the procedures in BS ISO 14520 Annex E Door fan test for determining of minimum hold time. The door fan test kit is shown in Figure 3.

Figure 3 – Room integrity testing equipment

The equipment was installed into the test room doorway. The G & D report states that both 'set-up' and 'gauge zeroing' was performed. The unit was used to both over pressurise and under pressurise the room to determine leakage. The following tests were conducted:

1. Sealed room integrity; determination of estimated leakage area (ELA)
2. Room integrity with installed pressure relief vent; determination of estimated leakage area
3. Gradual increase in room pressure to determine initial vent blade opening pressure
4. Determination of room pressure necessary to fully open pressure vent blades

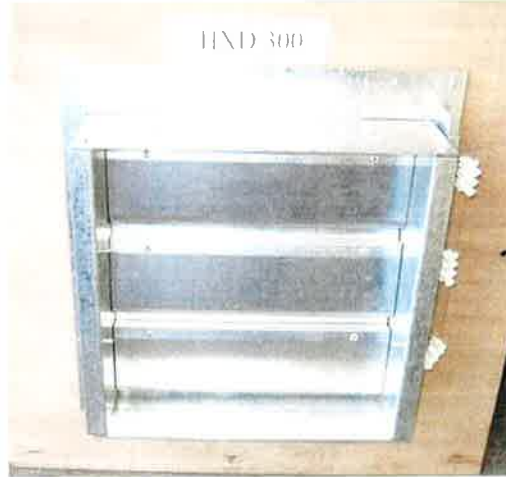
Figure 4 – AFP's HXD300 vent

1. AFP's 'HXD300' vent, 300 x 300 mm opening and 3 vent blades, see Figure 4.
2. AFP's 'SHX300' vent, 300 x 300 mm opening and 3 balanced weighted vent blades, see Figure 5.
3. AES vent, 300 x 300 mm opening and 4 'top' hinged 'bottom' weighted vent blades, see Figure 6.

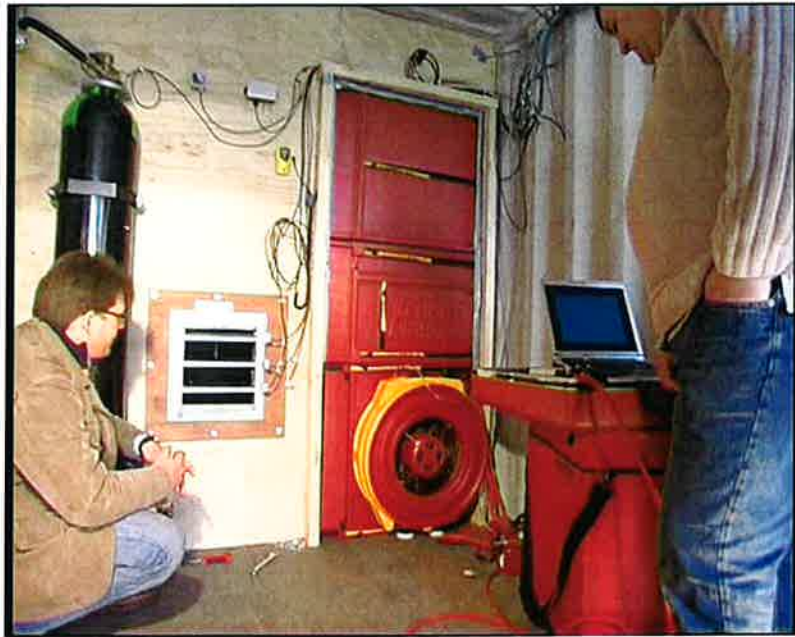
SHX Pressure Vent Being Tested

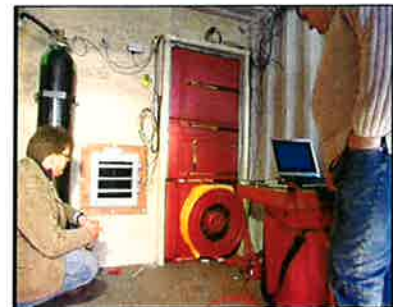
A standard Room Integrity Test was carried Out to determine the leakage area of our HXD300 Pressure vent and the risk. Results:-

Risk Volume	43.013m ³
Actual Risk Leakage	0.0106m ²
Predicted Retention Time	31.2 min

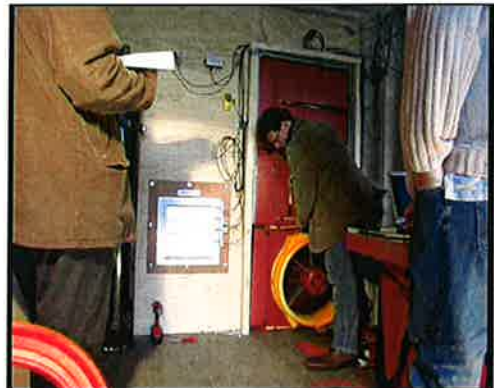
Vent Blades opened	170 Pascal's
9% FVA Open	429 Pascal's

AES 300 fan test with holding kit in as pressure gets to 429 Pascal's

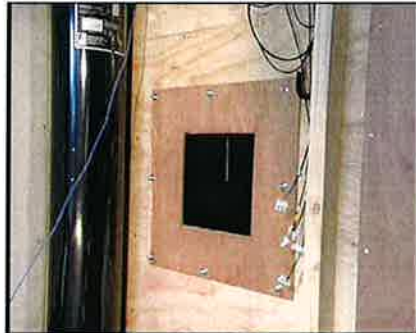
Photo of Open Hole Test
Hole size 300mm x 300mm giving a
FVA of 0.09m²

A full discharge of the gas with a 300mm x 300mm square hole providing 0.09 m² of Free Vent Area (FVA). This equalled the exact full and unobstructed opening area of all the pressure vents tested. We needed to determine the risk pressure with an open hole as a bench mark of the VDS Calc's and to determine the back pressure of the vents to be tested so that we could calculate the co-efficient of each unit and have an understanding of the safety factors used.

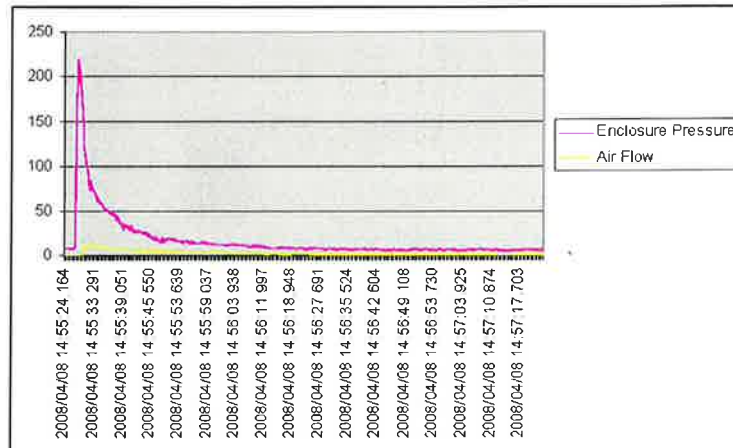
The maximum pressure reached in the test enclosure was 219.4571 Pascal's (Pa).

This gave us the base pressure which was more than half the pressure limit of 500 Pa

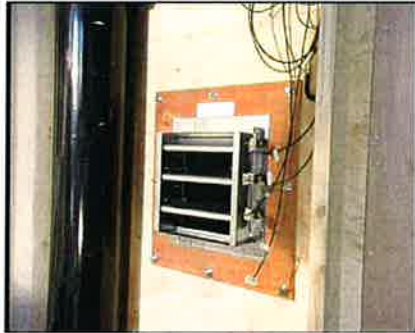
Photo of HXD300 fully open in live gas discharge

The HXD300 pressure vent was then installed and linked up to the recording device so that the vent blade positions could be accurately monitored and a discharge test carried out. This verified that the pressure vent fully opened and that the peak pressure in the enclosure reached 350 Pascal's.

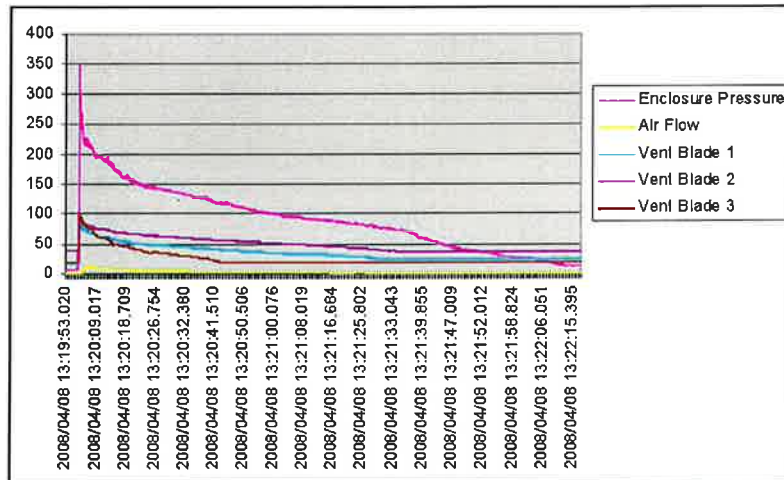
Results

This performed with in the maximum 500 Pa pressure and gave a good safety margin.

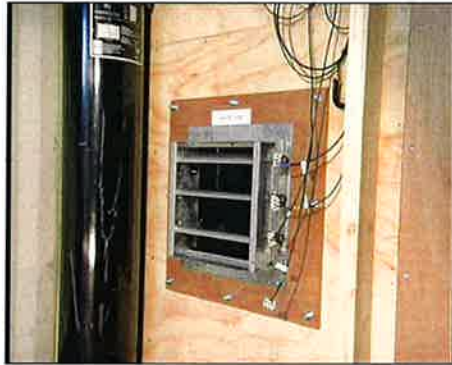
Photo of SHX 300 fully open in live gas discharge

The SHX300 pressure vent was installed and a gas discharge carried out.

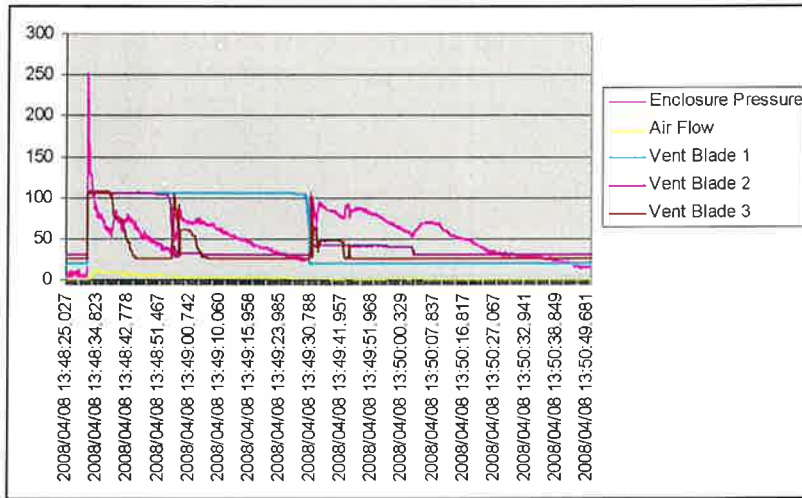
Results

Enclosure Pressure	251.7729 Pascal's
Air Flow through the pressure vent	10.37014 mps
The pressure vent fully opened	Yes

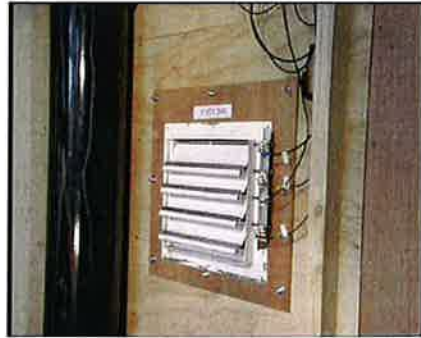
Photo of AES300 pressure vent with risk pressure at 790 Pascals. Vent in maximum open position.

The AES300 vent was then installed and the same discharge test was carried out.

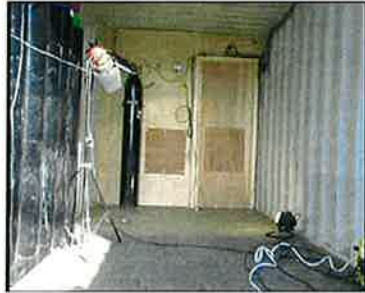
Photo of IG55 discharge with no venting risk pressure reached 1700 Pa

This test was carried out using IG55 Inert Gas with out any pressure venting to see what pressure the enclosure would reach before any damage was caused.

The first test reached 1700 Pascal's pressure before the risk was damaged. We then repaired the risk and carried out our first Cascade Vent Test with the container doors closed but with a very small amount of leakage and an SHX-300 Pressure vent in the inside wall. The following chart shows the resultant risk pressure.

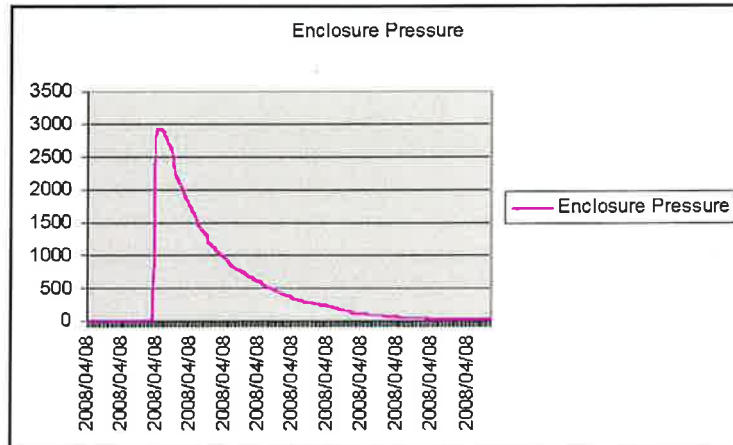
Results

No Pressure Vent Fitted

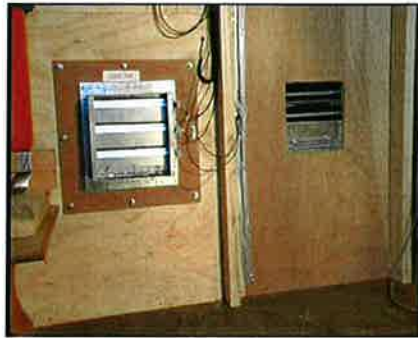
← Photo 1 of FM200 Negative Pressure Vent Opening (Bottom blade locked shut)

The system used two vents but we fixed one blade in each vent closed as the Free Vent Areas required was less than the above inert gas tests. Both vents were operated and the peek negative pressure reached was as followed:-

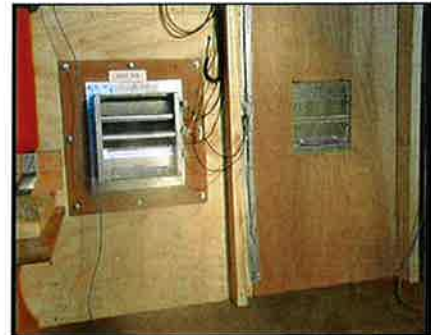
Photo 2 of FM200 Positive Pressure Vent Opening (Bottom blade locked shut) →

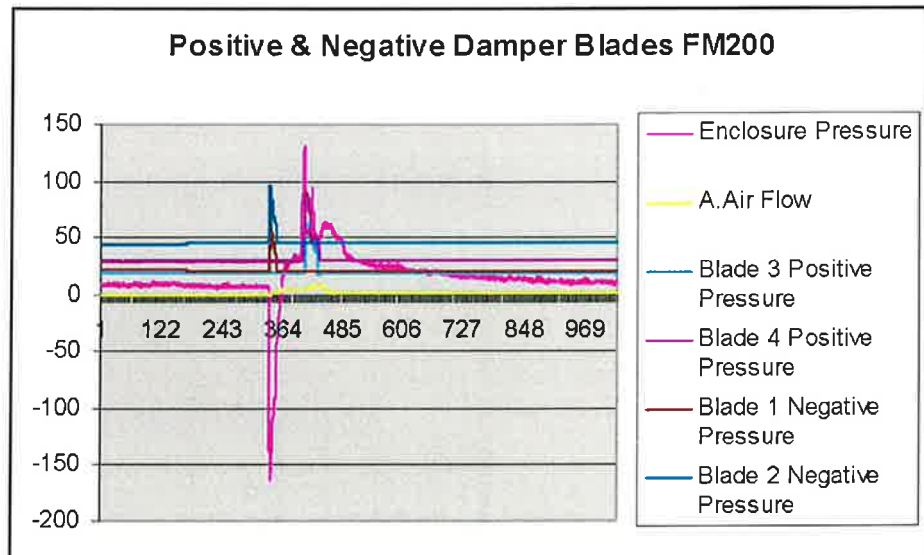
Enclosure Pressure	Neg – 163.987 Pascal's Pos + 129.9446 Pascal's
Air Flow through the pressure vent	+8.42154 mps
The pressure vent fully opened	NO
The vent blades open 45-50%
